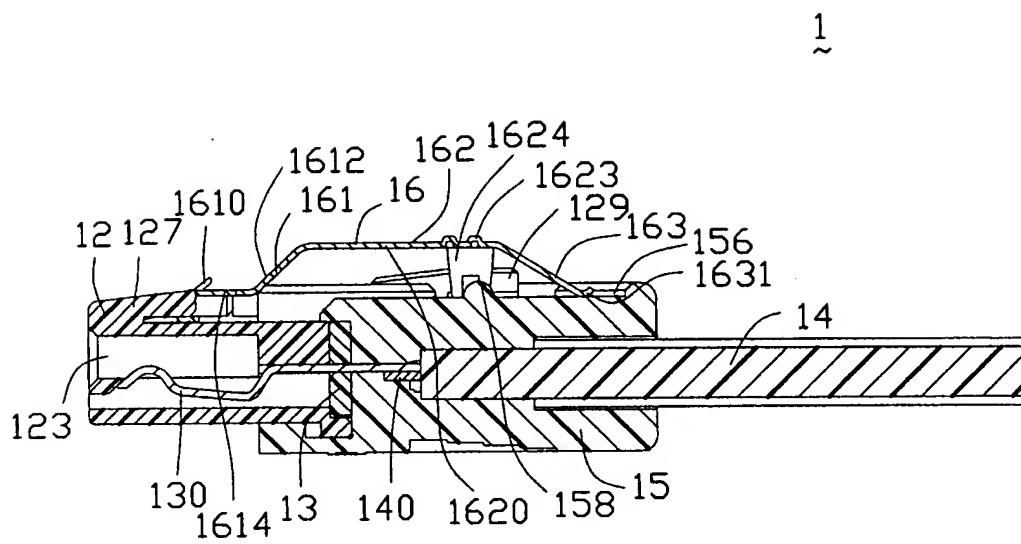
FIG. 9

This cross-sectional view shows a shaft (14) passing through a housing assembly. The shaft has a central section (15) with a keyway (13) and a flange (16) at the right end. The housing assembly includes a main body (12) with a bore (127) and a flange (1274) on the left. A seal (1601) is located between the shaft and the housing. A bearing (162) is mounted on the shaft, and a cap screw (1622) secures the housing. Other components labeled include 161, 1624, 129, 163, 1631, 156, 158, 15, 1620, 140, 13, 127, and 1270.
